Lowick Community Hall Technical and Maintenance Report 2019/2020

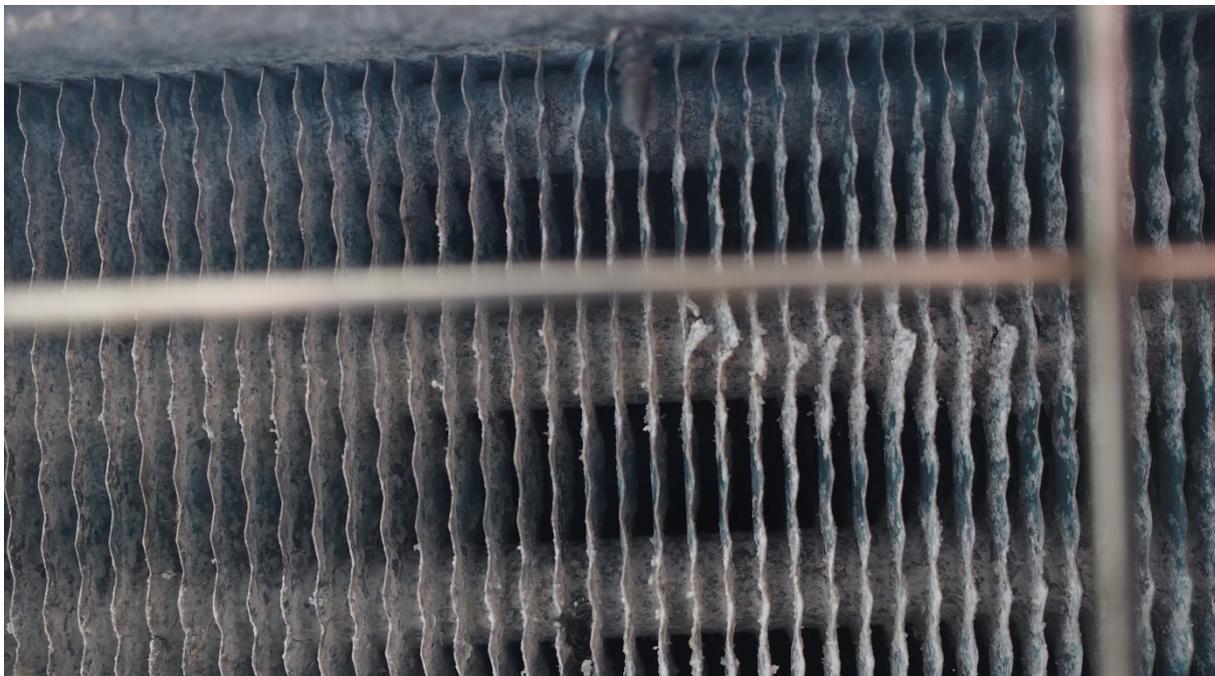
The heat pump was checked over on 11 September, the top was removed, cobwebs blown out and the unit run on test for 24 hours; it operated satisfactorily and was shut down again. Corrosion of the fan guard has now reached a point where the bottom of the guard is beginning to fall away; this does not represent a hazard whilst the casings are in place but would be a problem if an engineer needed to run the unit with casings removed for repairs (See Photo 2). I will see if something can be fabricated. There is also some corrosion to the unit chassis, this is minor but I will apply some treatment to stop it progressing. Corrosion of the evaporator fins has progressed little since last year's inspection (See photo 1). We need to plan replacement in the next 3 – 4 years.

Photo 1; Heat Pump:- Corrosion to Evaporator Fins

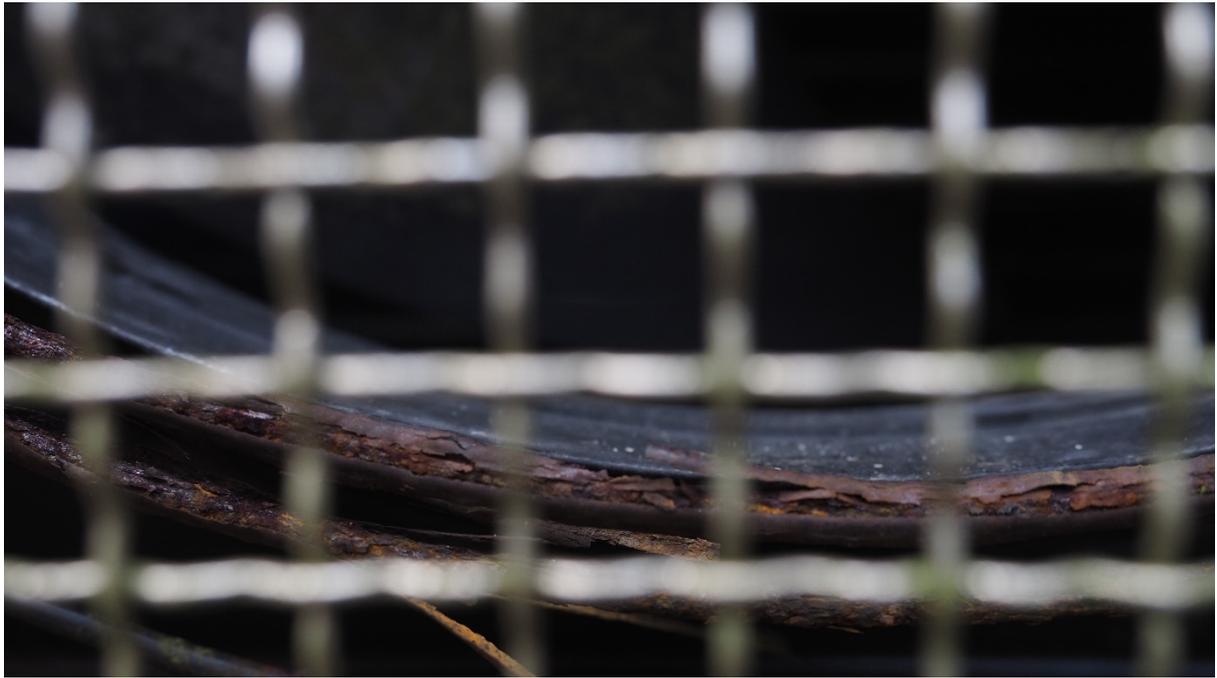
Photo 2; Heat Pump:- Corrosion of Interior Fan Guard.
